RAILROAD ACCIDENT REPORT

**HEAD-ON COLLISION OF
BURLINGTON NORTHERN
RAILROAD COMPANY FREIGHT TRAINS
EXTRA 6311 WEST AND
EXTRA 6575 EAST
NEAR WESTMINSTER, COLORADO
AUGUST 2, 1985**

NTSB/RAR-86/02

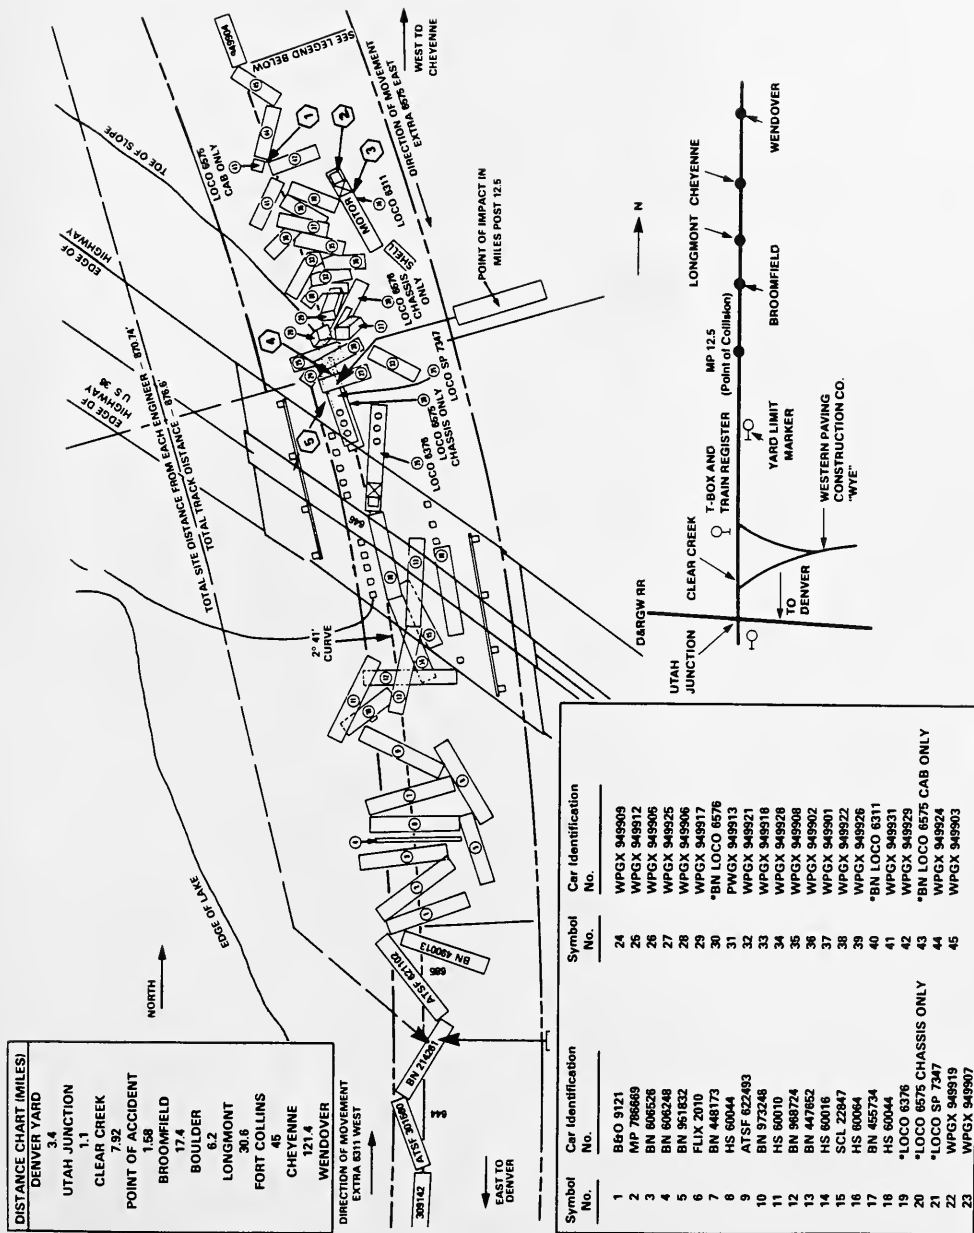
Figure 1.--Plan view of derailment.

Extra 6575 East.--Extra 6575 East, a unit gravel train ^{1/} operating between Longmont and Clear Creek, Colorado, was scheduled to leave Longmont at 2 p.m. (See figure 1.) Because there were no car inspectors located at Longmont, the three-man crew, consisting of the engineer, the conductor, and the brakeman, inspected the train and made a brake test, as required by Federal regulations. The inspection and brake test were completed at 3:15 p.m., and no exceptions were taken to the brakes or the mechanical condition of the equipment.

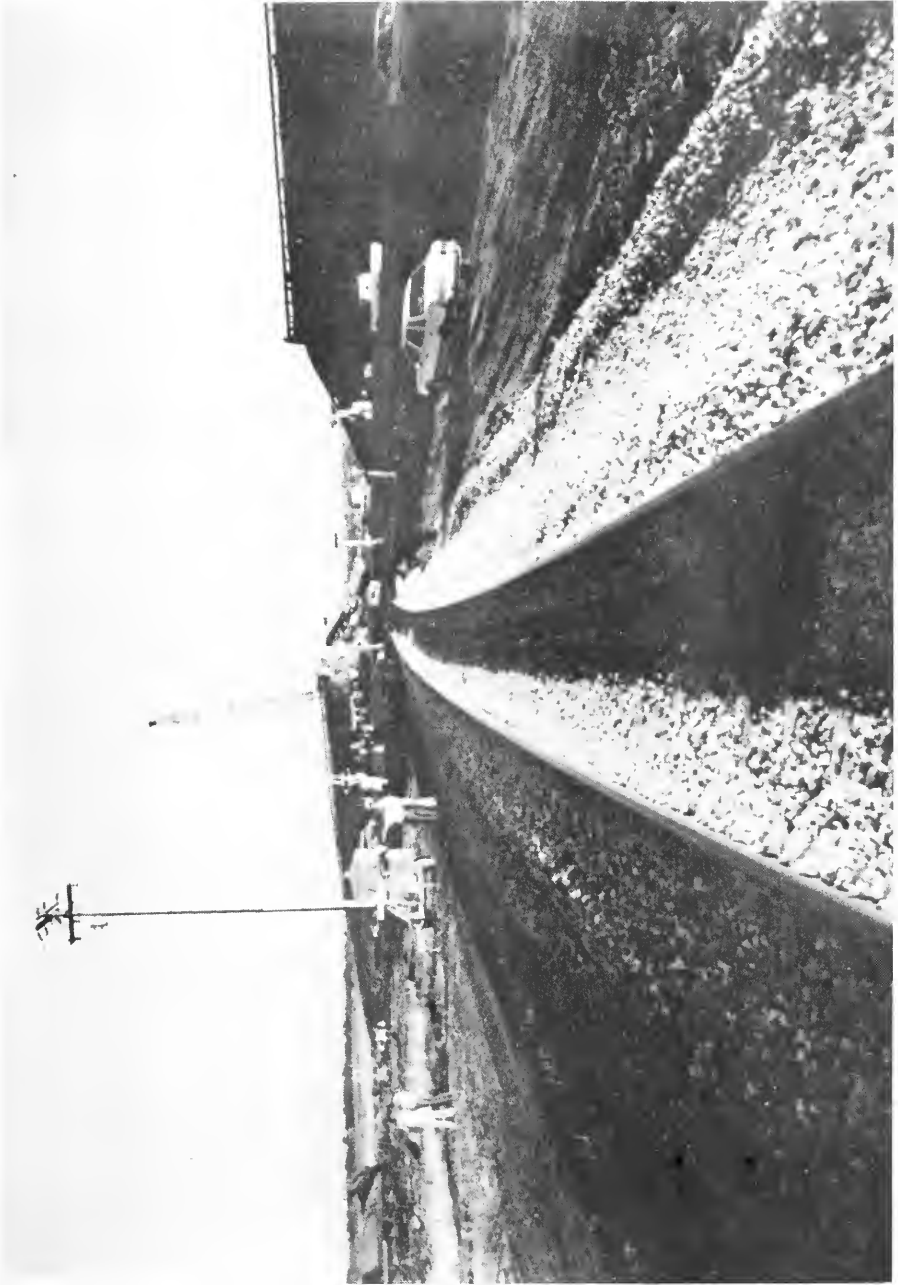
Figure 2.--Approach view eastbound of curve at MP 12.5 for Extra 6575 East.

When the train was near Broomfield, Colorado (MP 14), the conductor moved to the right side of the cupola in the caboose to observe the train as it moved around a right-hand curve near Broomfield. He said that he took no exceptions to the train's condition or to the manner in which the engineer was handling the train. He remained on the right side of the cupola until the train approached a curve at MP 12.5 so he could inspect the train as it moved around the curve. (See figure 2.) The conductor said that as the train was moving through the curve, he suddenly saw the headlight of a westbound locomotive emerge from under the highway bridge, and knowing the trains were going to collide, he braced himself.

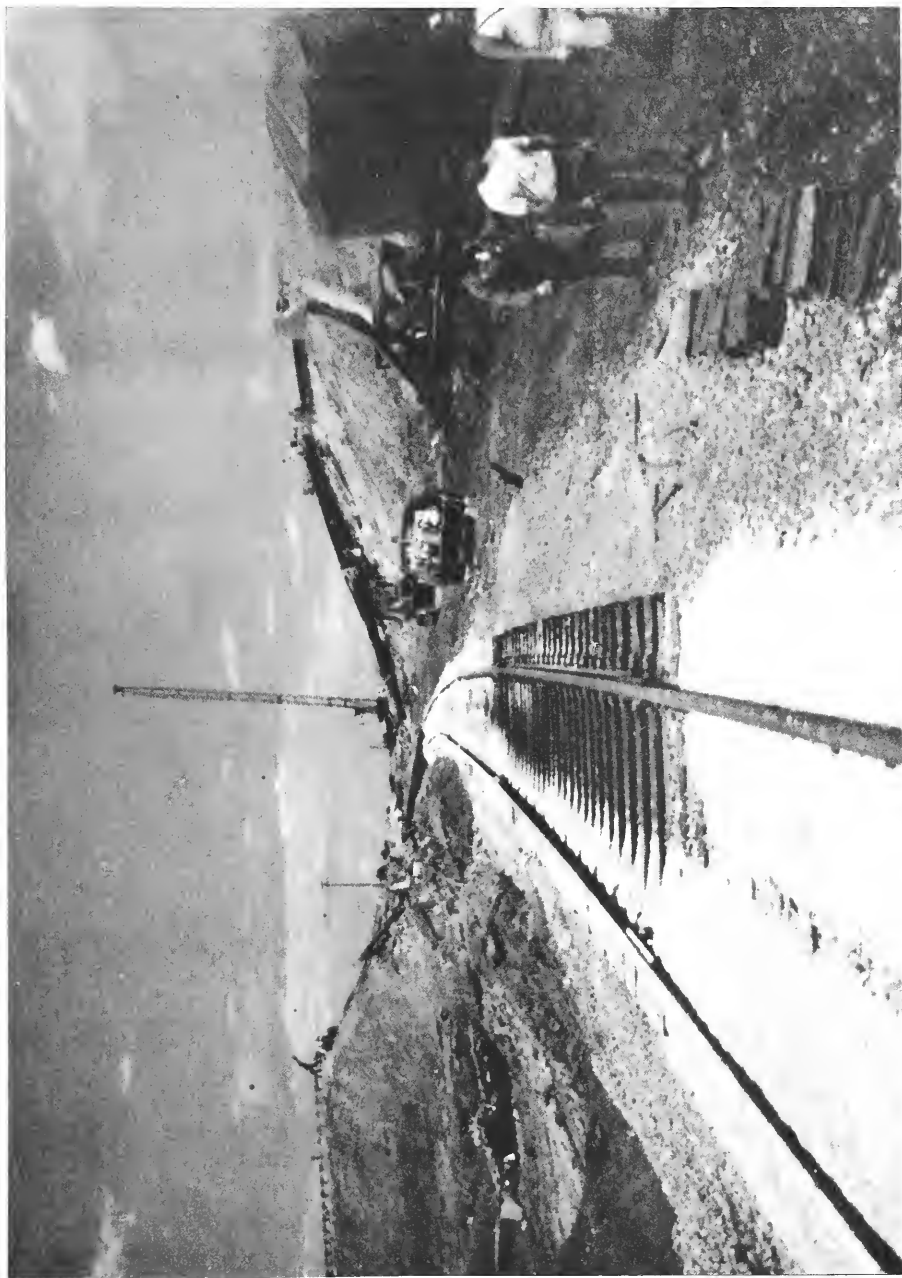
Figure 3.--Approach view to curve at MP 12.5 for Extra 6311 West.

About 7:40 p.m., the train emerged from beneath a dual-lane bridge on U.S. Highway 36, the Boulder Turnpike, near MP 12.5. Extra 6311 West, which was traveling about 52 mph, collided head-on with Extra 6575 East, which was traveling about 48 mph. (See figure 3.)

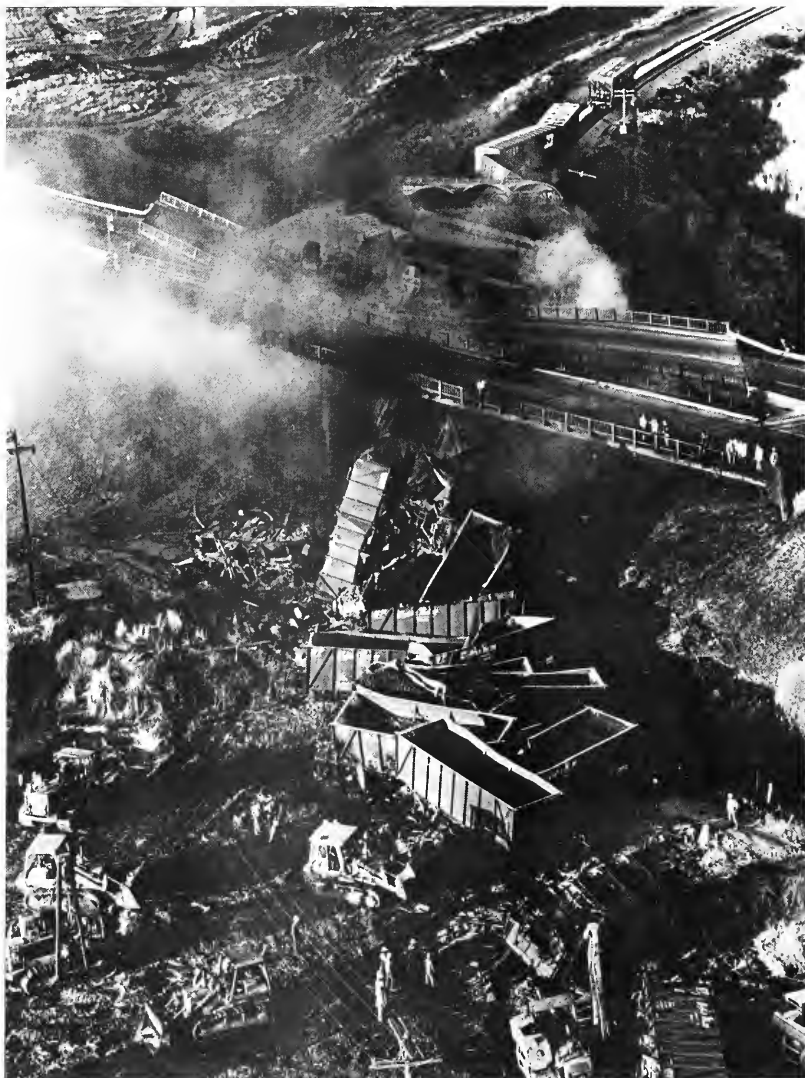
The three locomotive units of Extra 6311 West and the two locomotive units of Extra 6575 East were destroyed because of structural damage from the collision and the ensuing fire. Also 38 freight cars were destroyed. The impact forces of the derailling/piling cars against the highway bridge support members and the heat from the fire caused the bridge to buckle and distort to partial destruction so that it had to be torn out and rebuilt. (See figures 4 and 5.) About 900 feet of the main track were destroyed.

Figure 4.--Wreckage looking east.

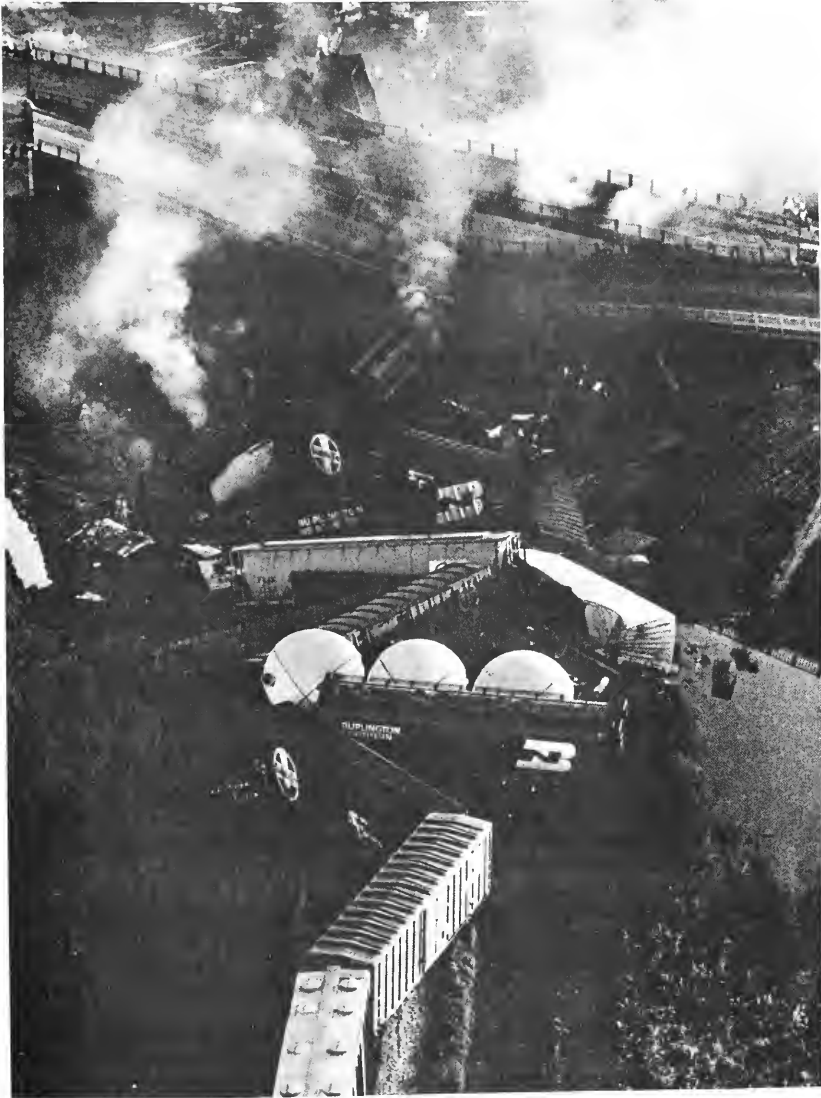
Figure 5.--Wreckage looking west.

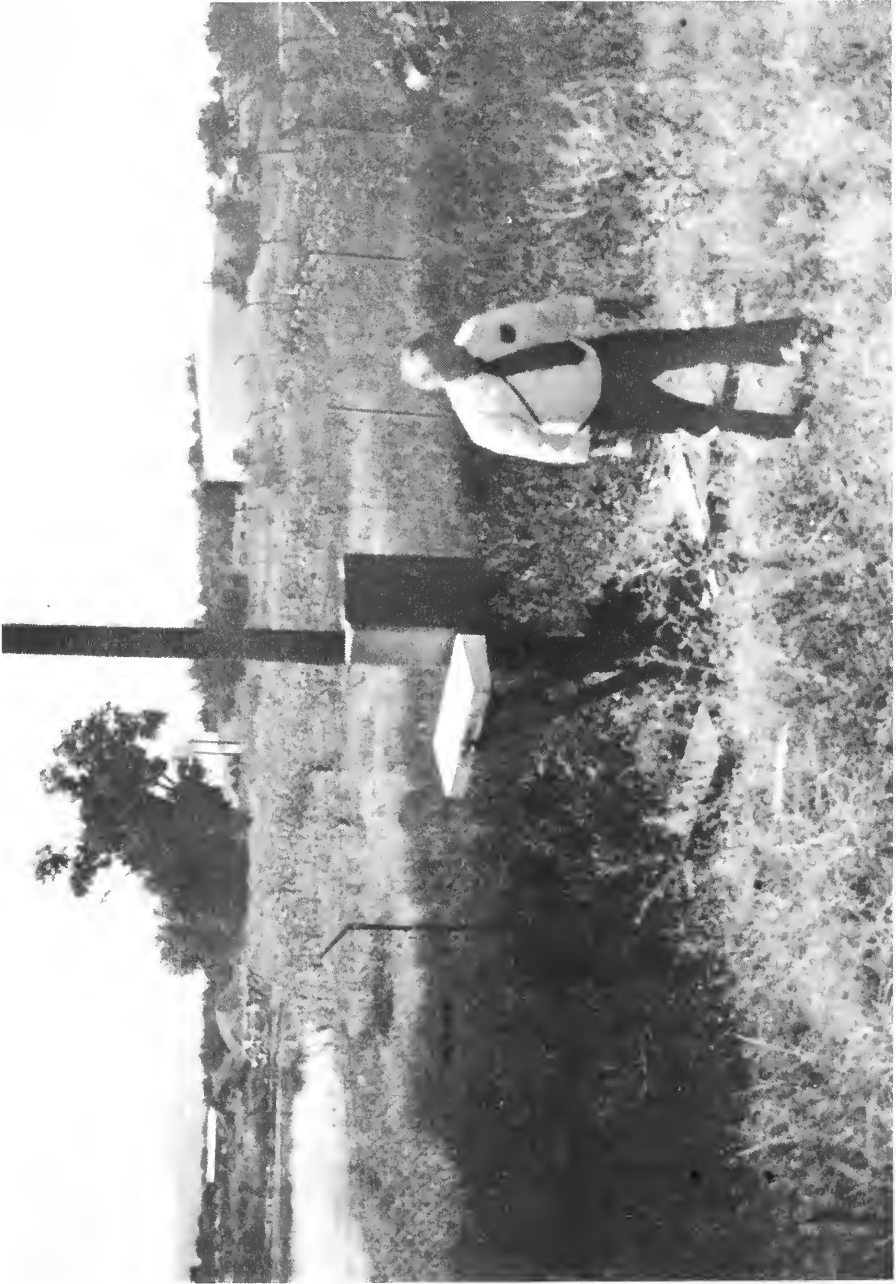
Figure 7.--Train register box and T-box at Clear Creek.

When one of the crewmembers on the locomotive of Extra 6311 West checked the train register at Clear Creek, he failed to perceive that the information recorded in the train register book was about Extra 6575 East of August 1. As a result of his misperception, he provided the other crewmembers with the incorrect information about Extra 6575 East. There were no surviving witnesses who could testify that they saw the crewmember unlock the register box, remove the train register book, and read the entries. The train was standing between the witness in the Western River Paving Construction Company so the witness' vision was blocked. However, since the 4:40 p.m. time quoted by a crewmember in the radio report to the conductor is a factual entry of record, the Safety Board concludes the train register book was removed from its repository and viewed by a crewmember. Since it is not known for certain who read the train register, the Safety Board could not determine the circumstances surrounding the dissemination of incorrect train register information. Although the tape recording of the radio message from the crewmember on the locomotive was not of good quality, probably because of the distance between Clear Creek and the Longmont radio base station, the reception of the message on the caboose by the conductor would have been more easily understood.
